# The Application of Monitoring and Early Warning System of Rainfall-Triggered Debris Flow at Merapi Volcano, Central Java, Indonesia

Teuku Faisal Fathani and Djoko Legono

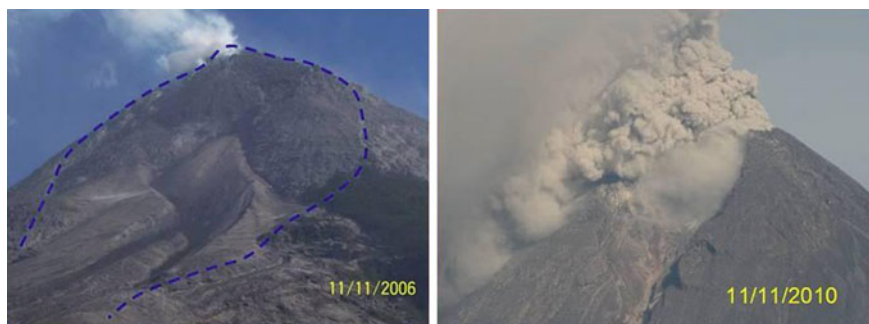
**Fig. 1** Merapi volcano before the 2010 eruption

It was reported that the 2006 Mt. Merapi eruption (from April through October 2006) had produced approximately 8 million m<sup>3</sup> of sediment, which has high potential to move downstream towards the southern part of the mountain (Legono et al. 2008). Meanwhile, the 2010 Mt. Merapi eruption (from 25 October through 2 December 2010) produced approximately 140 million m<sup>3</sup> of pyroclastic deposit toward the southern and western part of the mountain (Legono et al. 2011a). Since then, the volcanic debris flow has caused severe damage to the inhabitants and residents living on the foot slopes. Figure 1 shows the Merapi volcano before and after 2010 eruption.

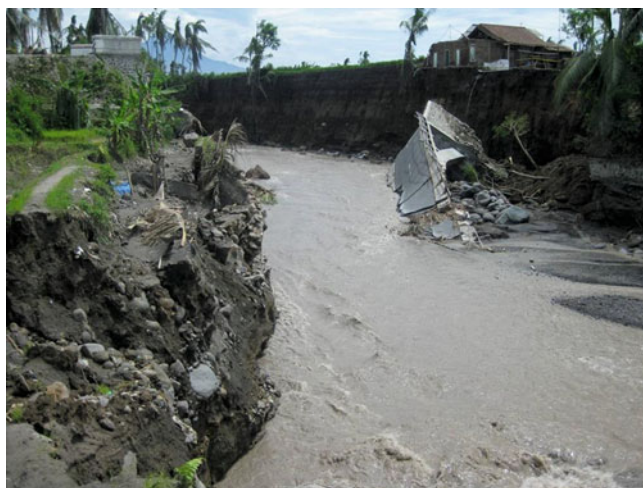
**Fig. 2** Collapsed bridge due to the destructive power of rainfall-induced debris flow

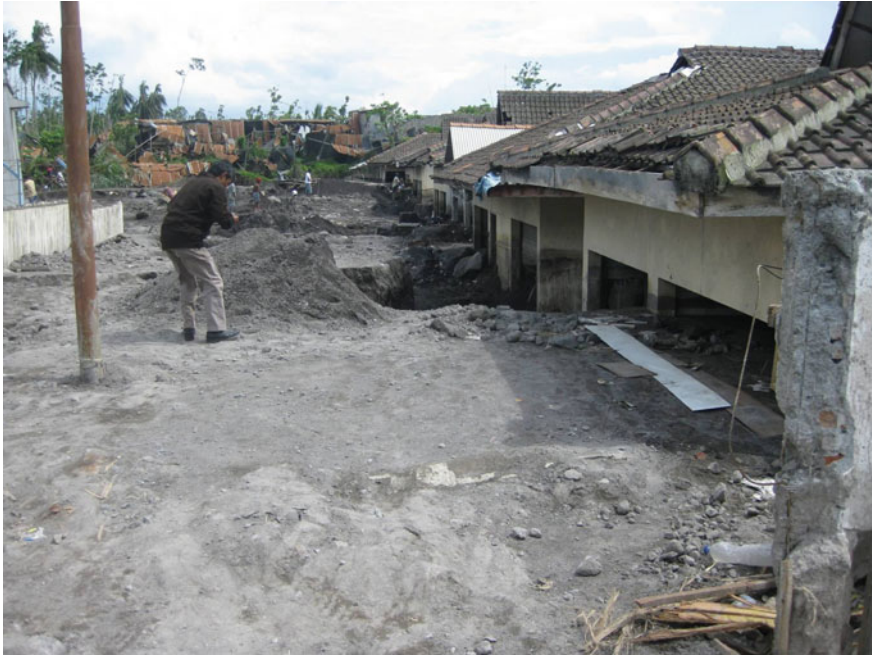
**Fig. 3** Damage on houses near the volcanic river

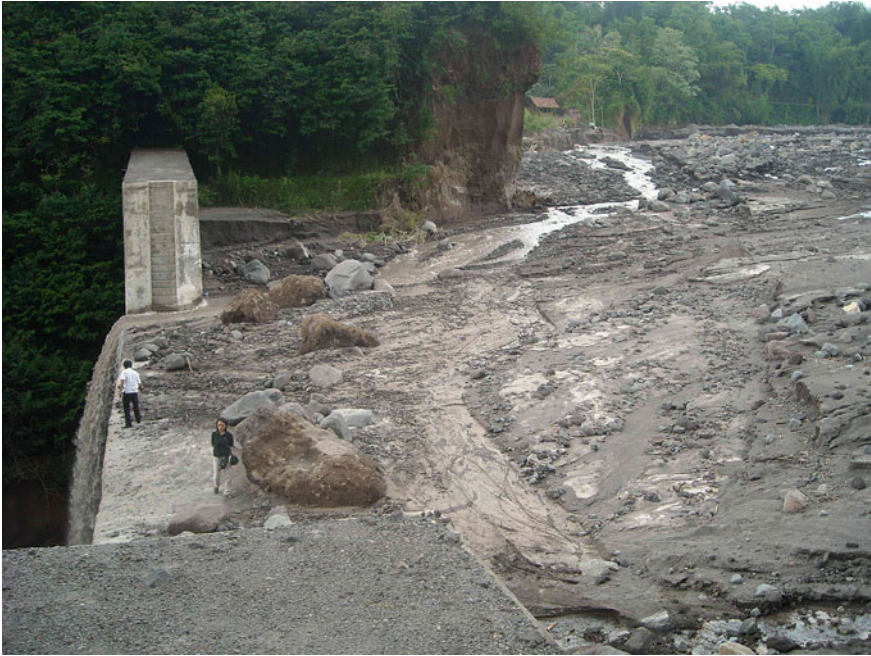
**Fig. 5** Upstream condition of Boyong River: Sabo dam BOD4 on 14 January 2011

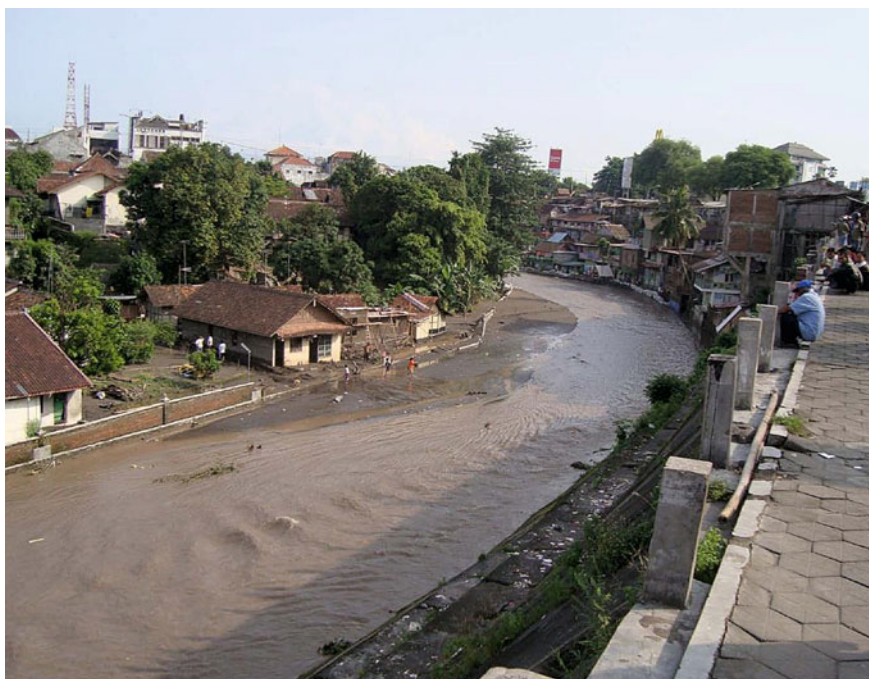
**Fig. 6** Downstream condition of Code River: Jogoyudan area in the Yogyakarta City on 30 November 2010

Apparently, during the days after 29 November 2010, increase in rainfall intensity occurred, triggering a more intensive debris flow that caused significant damages in several infrastructures at some rivers (Pabelan River and Putih River). Fortunately, no casualty was reported. However, the damage of important infrastructures such as roads, bridges, paddy fields, and settlements was very significant. A hyper-concentrated flow in Boyong/Code River occurred several times that made the local people evacuate themselves (Fig. 6).

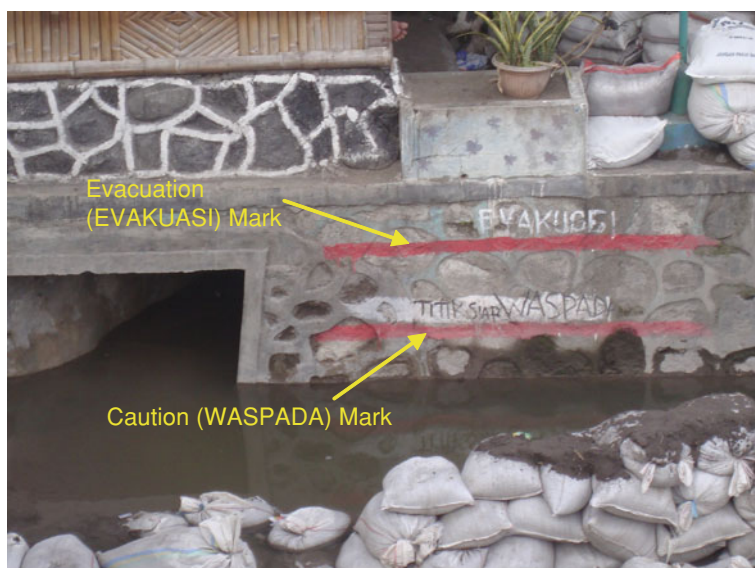
Figure 9 shows the current warning system pursued by the community at surrounding Code River. The community living near the river has tried to carry out debris flow monitoring with the simplest way. Based on the previous experience, “caution” and “evacuation” elevation are marked on the river slope protection; hence, they can decide the right time to evacuate. The presence of integrated debris flow early warning system indeed helps the community to increase their awareness and preparedness in facing the disaster.

**Fig. 9** Existing community warning alert in anticipating debris flow

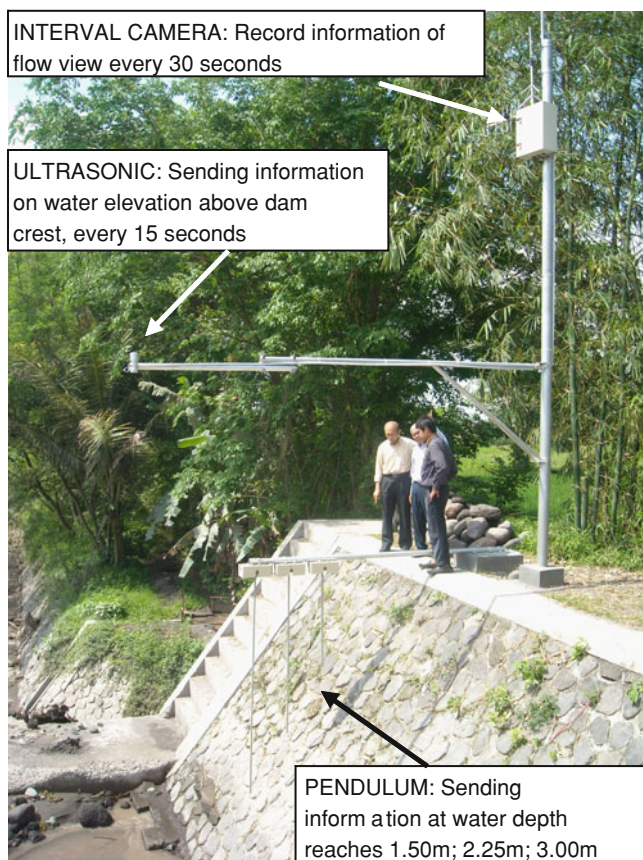
Figure 12 shows the cross-sectional monitoring system at Rejodani. Ultrasonic monitoring equipment, interval camera, and three different levels of pendulum are

**Fig. 12** Cross-sectional monitoring system at Rejodani

placed in one river cross-section. This system transfers the monitoring results regularly to the central station. The whole system was built by prioritizing most adaptive and least cost technology. Through this system, a debris flow monitoring system of Boyong/Code River for community at Yogyakarta City is implemented. This monitoring system is easy to replicate for rivers threatened by debris flow disaster at the surrounding of Mt. Merapi area.
